# BP.4271 50' Car 7'10" Wide - Body General Arrangement

Sourced from John Agnew Collection - Scale 1:48

50 FT CAR 7' 10" WIDE

FIRST CLASS, SECOND CLASS, AND COMPO CARS

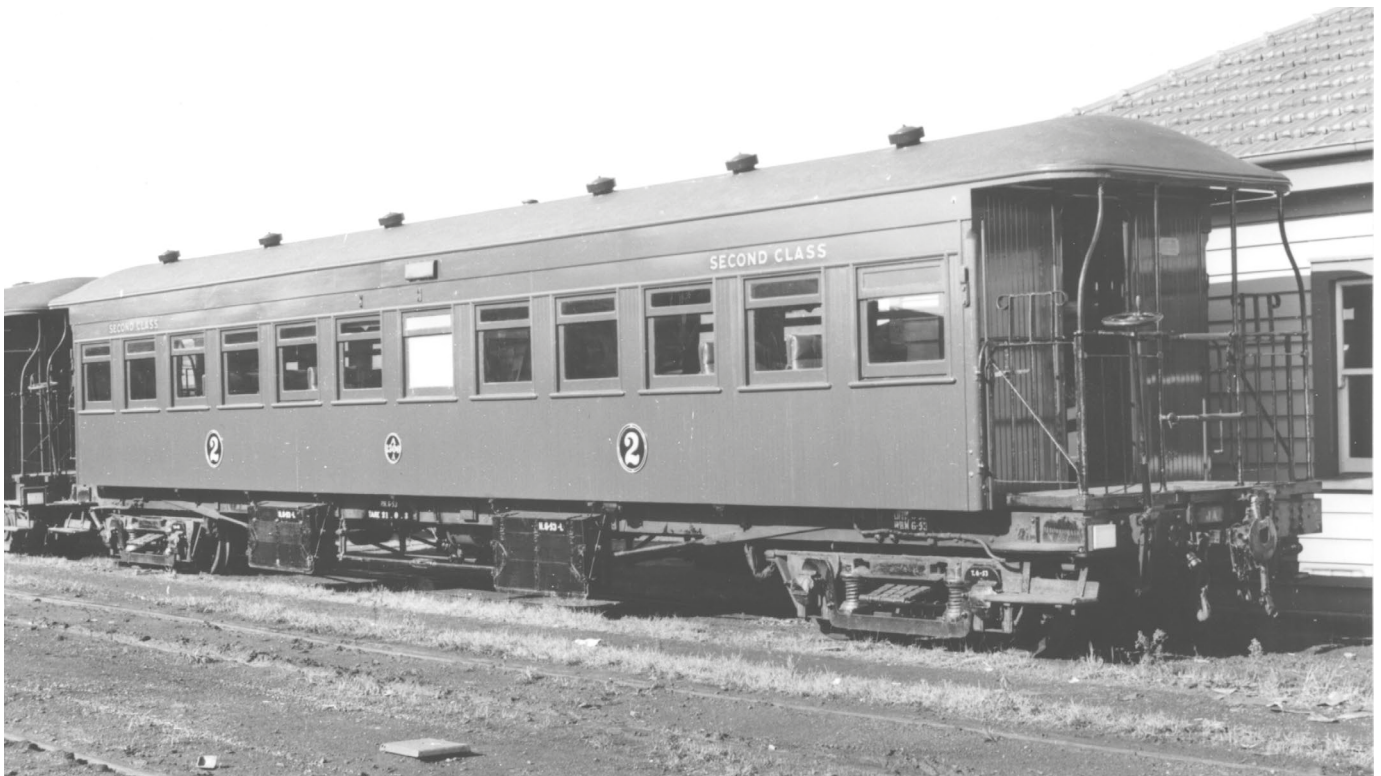
**Top left:** A1306 was recorded Auckland in 1953 fresh from maintenance with a new black roof and freshly painted battery boxes. Note the oiling tablet on the headstock.

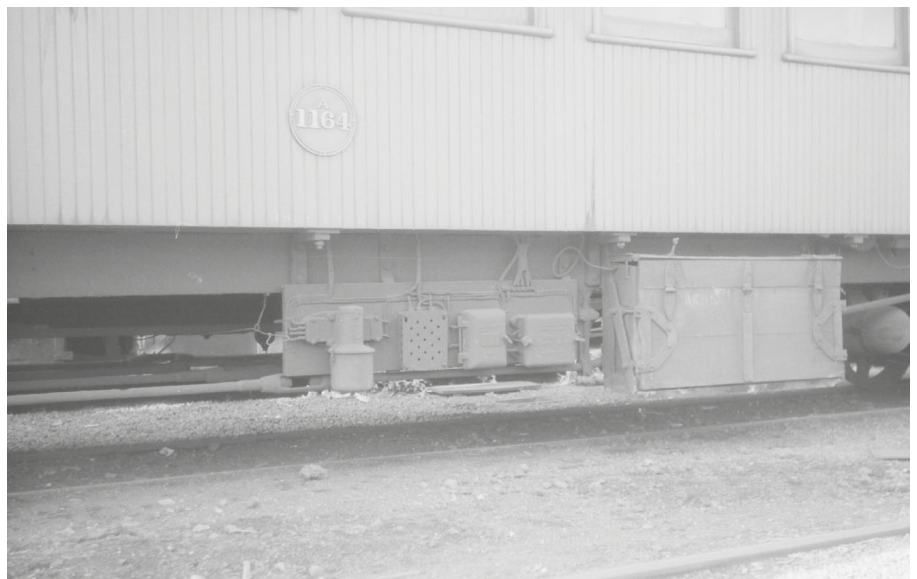
**Centre right:** Details of the electrical equipment on A 1164 showing both the switch gear and a battery box.
